# EXHIBIT I

*Documenta Ophthalmologica* 61, 303–312 (1986).  
© Dr W. Junk Publishers, Dordrecht. Printed in The Netherlands.

## Mechanical and biochemical effects of man-made fibres and metals in the human eye, a SEM-study

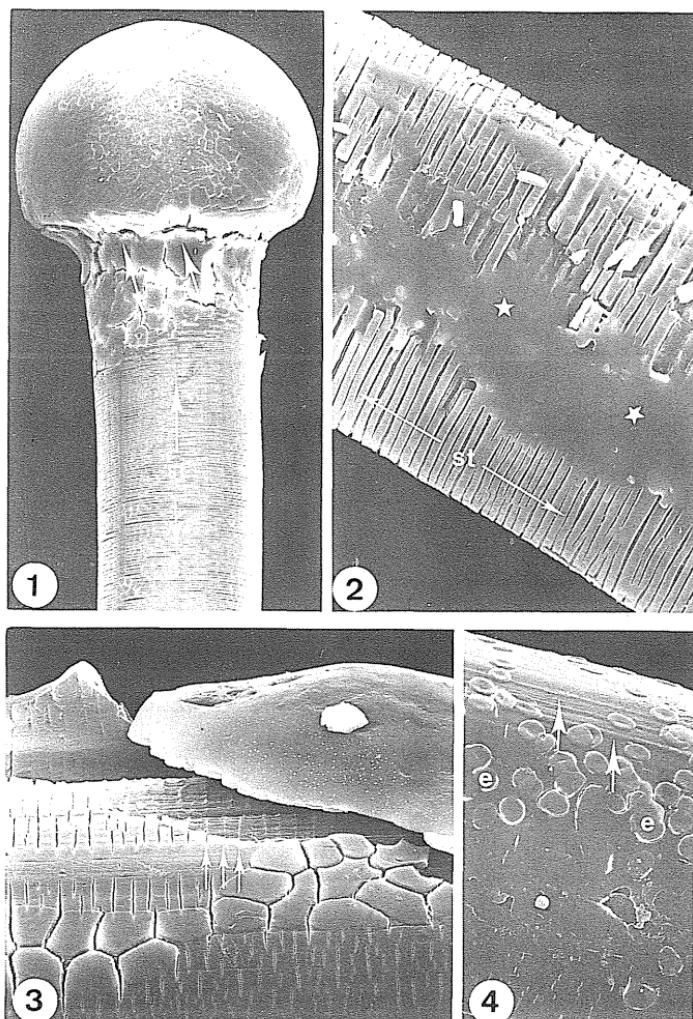
Both prolene loops showed severe degradation of the surface layer. Figure 1 shows part of one of the loops with a very regular pattern of striations (st) perpendicular to the longitudinal axis of the loop. The rounded end of the loop and the beginning of the straight part of the loop are covered with a rather thick layer of deposits of an unknown substance which contains many erythrocytes (e). The irregular cracks in this deposit (see arrows) are due to drying, a common phenomenon in SEM-specimens of inhomogenous structure. Figure 2 shows at higher magnification the very regular pattern of striations (st); some parts of the surface are covered with a thin deposit (\*), comparable to the layer seen in Figure 1. The degradation of the surface layer can be observed in more detail in Figure 3. Part of the surface layer is detached, exposing the *sub*-surface layer, which shows a similar cracking pattern (see arrows). Although the cracking can have been enhanced by the drying process, the loops and lens were dried in air, the fact that the *sub*-surface layer shows a similar cracking pattern of degradation is a clear indication of biodegradation. If the phenomenon we observe were the result of the drying of a deposit, then the cracks in it would have a much more irregular character, like the cracks seen in Figure 1 on the rounded top. Moreover the total diameter of the degraded loop has certainly not increased, which would be the case if the result we observe was caused by the deposition of material.

That part of the loop (close to the lens) which was not in contact with tissue did not show the degradation phenomenon, but was merely covered with a very thin deposit, consisting mainly of erythrocytes (e), Figure 4. The layer of deposit is very thin, as can be concluded from the longitudinal lines, caused by the manufacturing process, which are still visible despite the deposit (see arrows).

Figures 1-4. Prolene: Figure 1 (155 X), part of prolene loop; e = erythrocyte covering; st = striations of biodegradation; arrows denote deposited organic matter. Figure 2 (370 X), degraded surface; \* = deposited organic matter; st = regular pattern of striations. Figure 3 (770 X), detail of degraded surface layer. Figure 4 (370 X), non-degraded prolene surface; e = erythrocytes; arrows denote manufacturing grooves.

We think that the surface changes observed in the implanted prolene are the result of biodegradation by the enzymatic action of the tissue fluids. Although the cracking pattern on the surface may be enhanced by the drying, the changes are the primary result of chemical changes on the surface.

This conclusion is supported by the images of the *sub*-surface layer, where lines appear perpendicular to the longitudinal axis of the loop, which are not present in the control sample. In some places a deposit is visible on top of the surface layer of the implanted prolene; this layer is very thin and not in any way comparable with the attacked layer. If the phenomenon of what we call biodegradation is the result of a deposit of, for example, a proteinic material, a quantitative increase in the average diameter would be the result. The total diameter at such sites did not increase but, on the contrary, tended to decrease slightly. Moreover the cracks (striations) are so regularly spaced over a large part of the implanted loops that they must be the result of prolene degradation and not of the mere drying of a deposit.

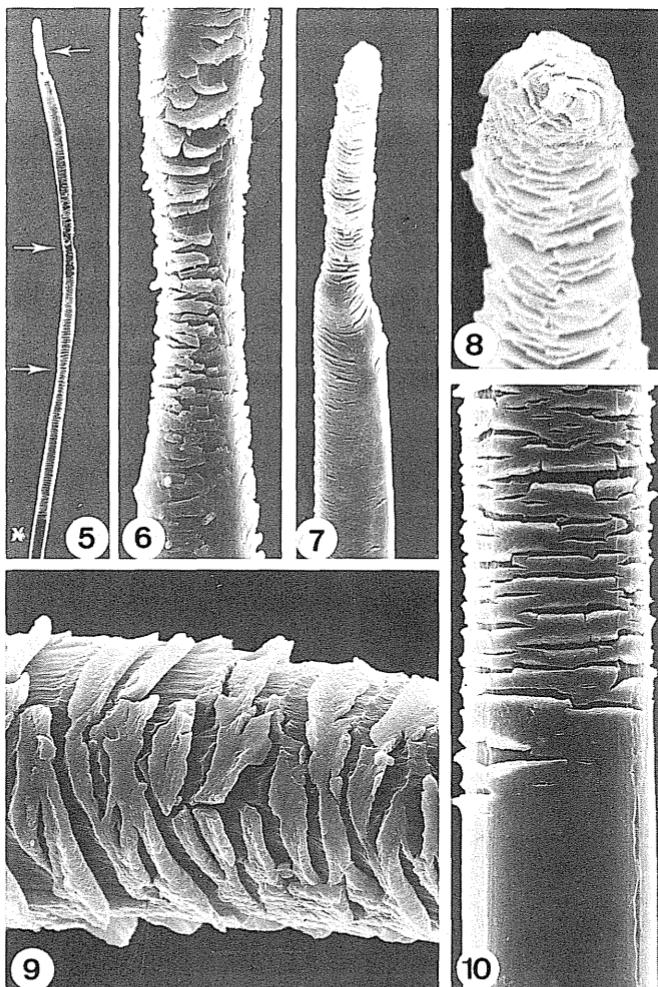
not show this. The attack was so serious that the ends became so thin that they lost their strength and broke off. Figure 5 shows the broken end of one of the sutures at low magnification. In several places (see arrows) the suture had a smaller diameter than average. This considerable decrease in diameter is something we did not observe with prolene. The main part of the suture in Figure 5 shows a degraded surface, except for the part indicated by (\*).

A thinner part of the suture is shown in more detail in Figure 6, the

Figures 5–10. Perlon: Figure 5 (38 $\times$ ), low magn. broken Strampelli suture; arrows denote decreased diameter; \* = non-degraded part. Figure 6 (390 $\times$ ), detail of suture with decreased diameter. Figure 7 (175 $\times$ ), broken end of suture. Figure 8 (595 $\times$ ), detail of Figure 7. Figure 9 (1330 $\times$ ), detail of degraded surface. Figure 10 (450 $\times$ ), transition non-degraded (lower part) – degraded surface.

surface of the suture is degraded. The broken end of the suture is depicted in Figure 7, it has a considerably decreased diameter and the surface is degraded. The broken end is shown in Figure 8 at high magnification, note the rough outer surface.

Although not exactly the same, the general pattern of degradation of the surface layers of perlon (Figure 9) and prolene (Figure 2) is comparable. A similar pattern is found on the sub-surface layer of perlon to that seen in

prolene. That part of the suture which had not been in contact with tissue did not show these effects of biodegradation. Figure 10 shows such a transition area in more detail, the lower part of the picture represents the non-degraded surface of the perlon structure.

The effects seen in the perlon material are also the result of biodegradation; in certain places the material got so thin that it lost its strength and broke. Supramid material showed minor degradation effects, longitudinal cracks which may be related to the manufacturing grooves to some extent. In one case (see Addendum) we found, in a very small portion of the total length of all the loops, a similar degradation effect to that seen in prolene and perlon. Thus supramid can undergo biodegradation as well.

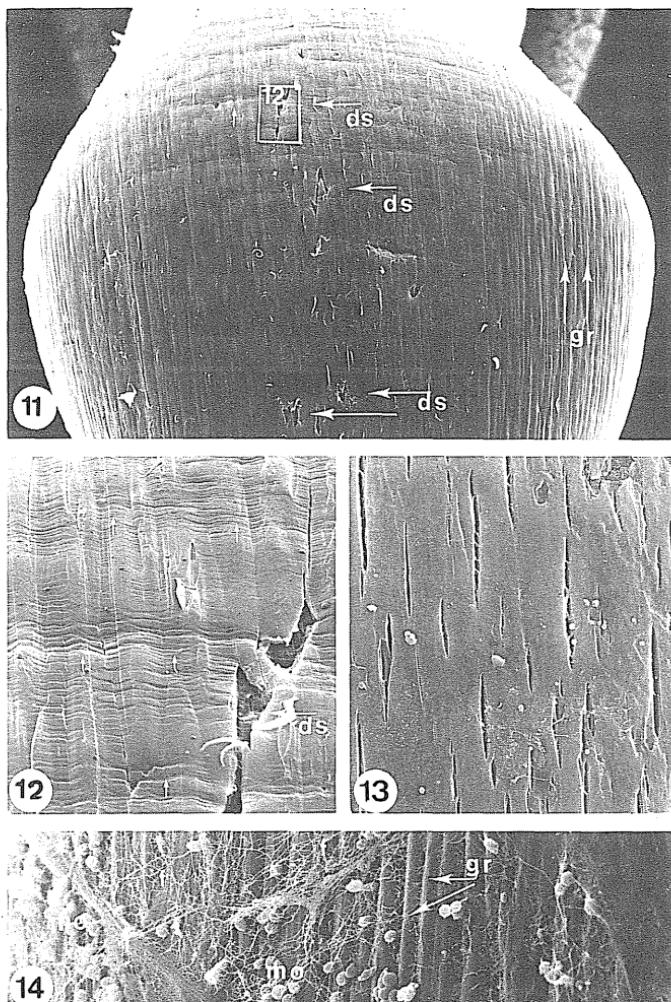
Figures 11–14. Supramid: Figure 11 (455 $\times$ ), bend in loop; gr = manufacturing grooves; p1 = lines perpendicular to grooves; ds = surface damage. Figure 12 (1530 $\times$ ), detail of Figure 11. Figure 13 (950 $\times$ ), longitudinal cracks in surface. Figure 14 (1530 $\times$ ), gr = manufacturing groove; f = fibres; mo = microorganisms.

The supramid material showed, in particular at bends in the loop, a fine network of lines (see arrows) perpendicular to the longitudinal manufacturing grooves (gr) of the loop (Figure 11). On the median part of the loop, clear evidence of surface layer damage can be seen (ds). Figure 12 shows a detail of such a site and its relationship to the fine network already mentioned. In Figure 13 longitudinal cracks are visible on the surface of the supramid loop, possibly the start of biodegradation. These cracks are found in the vicinity of bends in the loop at some distance from them, implying that this type of degradation is related to weak spots in the loop, particularly bends due to the manufacturing process. The general pattern of the surface is not one of severe degradation, as compared to the degradation seen in prolene and perlon, at least not in the loops we investigated.

The relatively rough outer surface of supramid, as compared with prolene and perlon, certainly facilitates the adherence of fibres, cells and micro-organisms, as can be seen in Figure 14. The picture shows the almost complete diameter of the loop with fibres (f), possibly fibrin, and microorganisms (mo) covering the manufacturing grooves (gr) of the supramid.

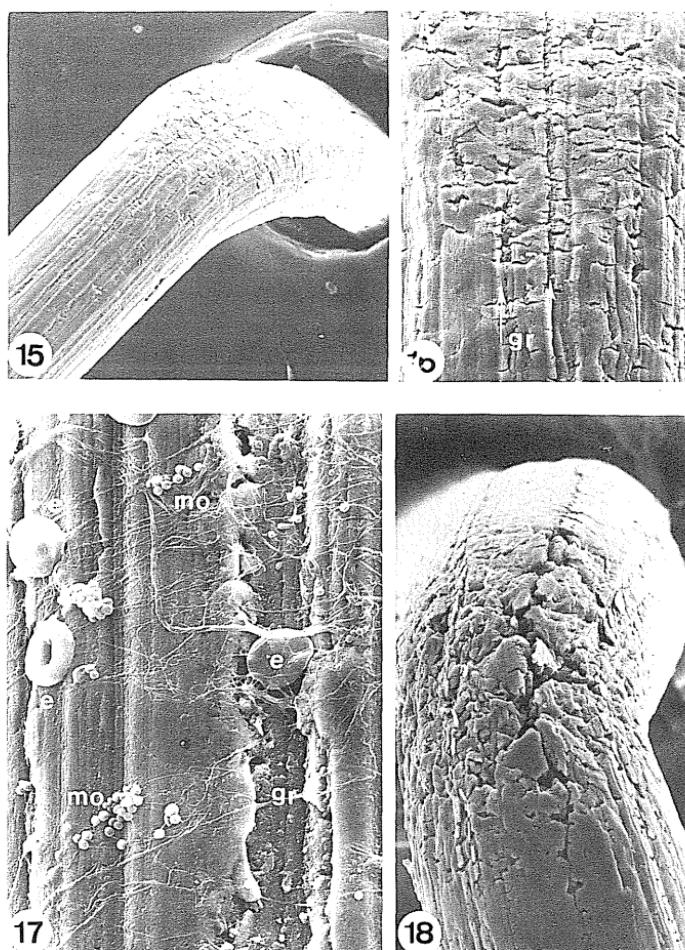
Titanium showed a rough outer surface, particularly at bends in the loop; in the straight part of the loop the longitudinal lines can be seen caused by the manufacturing process (Figure 15). The longitudinal grooves (gr) and the cracks more or less perpendicular to them can be seen in more detail in Figure 16 (area (A) of Figure 15). The roughness of the titanium surface facilitates the adherence of microorganisms (mo), fibre-like material and cells, especially erythrocytes (e), visible against the background of manufacturing grooves (gr) in Figure 17.

This roughness is already present in non-implanted material, as can be observed in Figure 18. The cracks in the surface layer particularly at the bends in the loop, visible in non-implanted as well as implanted material (see Figure 16), are some kind of mechanical degradation probably caused by, or at least initiated by, the manufacturing process.

This roughness also contributes considerably to irritation and inflammation of the tissue which is in contact with this material. In comparison with titanium, stainless steel-vanadium and, in particular, platinum wire have a much smoother surface.

Figures 15–18. Titanium: Figure 15 (190 $\times$ ), bend in implanted loop. Figure 16 (455 $\times$ ), detail of surface of bend; gr = grooves. Figure 17 (1230 $\times$ ), detail of loop surface; mo = microorganisms; e = erythrocytes; gr = manufacturing groove. Figure 18 (345 $\times$ ), detail of bend in non-implanted loop.

Both supramid and titanium have initially a rather rough outer surface, which facilitates adherence and, in the case of titanium, contributes to irritation and inflammation of the tissue with which it is in contact.

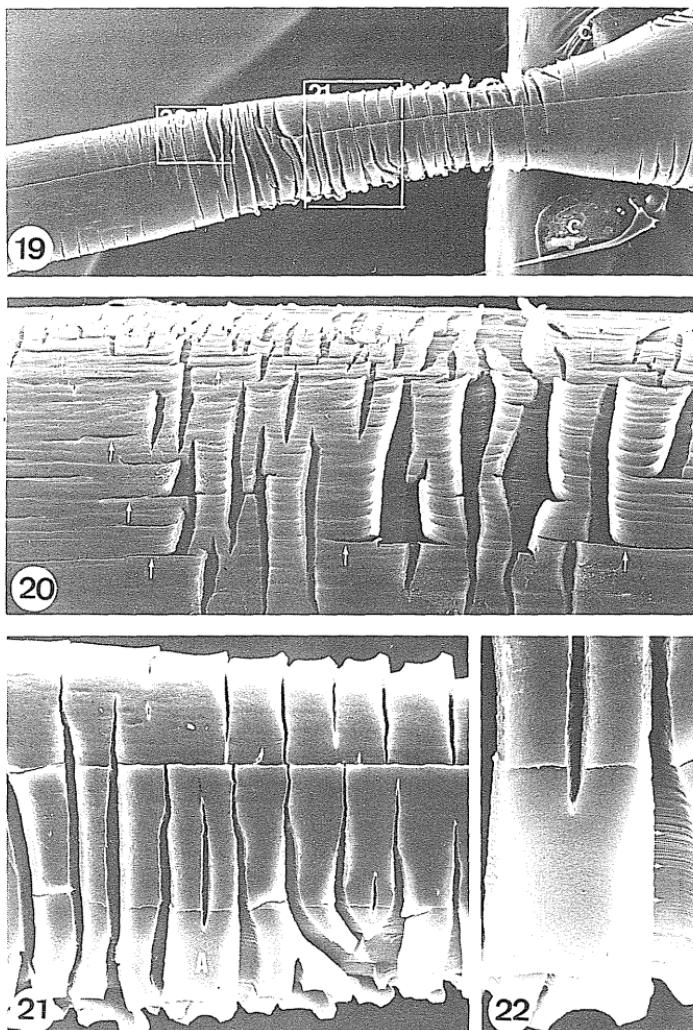
Very recently we investigated another Fedorov-type IOL with 4 supramid loops, which had remained for several years in the eye of a Dutch patient. The loops did not show any biodegradation, *except* for a small part of

one loop situated close to the IOL (see Figure 19), which showed severe biodegradation. The diameter of the loop had decreased at this site. The IOL showed some cell deposits around the loop 'entrance' (c). The degradation pattern is quite similar to that found in prolene and perlon (see Figures 20 and 21, both details of Figure 19). From Figure 20 it seems logical to assume that the degradation is connected with the surface morphology of the supramid surface. The longitudinal cracks (see arrows) are comparable with those found in Figure 13, which can be related to the manufacturing grooves. The

Figures 19–22; Supramid: Figure 19 (75  $\times$ ), part of loop close to IOL; c = cell deposit. Figure 20 (455  $\times$ ), detail of Figure 19; arrows denote longitudinal cracks. Figure 21 (275  $\times$ ), detail of Figure 19; severe degradation of surface. Figure 22 (610  $\times$ ), detail of Figure 21, inside of crack.

striations perpendicular to these cracks are comparable with the striations<sup>1</sup> found in prolene (Figure 2) and perlon (Figure 9), although less regular.

Figure 22 shows more detail of the inner part of the surface layer (enlargement of part of Figure 21). From this picture we can conclude that the loosened surface layer does *not* have an amorphous structure, which would be the case if it was merely a deposit of, for instance, proteinic material. Arrows denote the cross-section of the loosened surface layer.
